SECOND FIVE-YEAR REVIEW REPORT

**FORMER NAVAL CONSTRUCTION BATTALION CENTER DAVISVILLE
NORTH KINGSTOWN, RHODE ISLAND**

**COMPREHENSIVE LONG-TERM
ENVIRONMENTAL ACTION - NAVY (CLEAN) CONTRACT**

March 2008

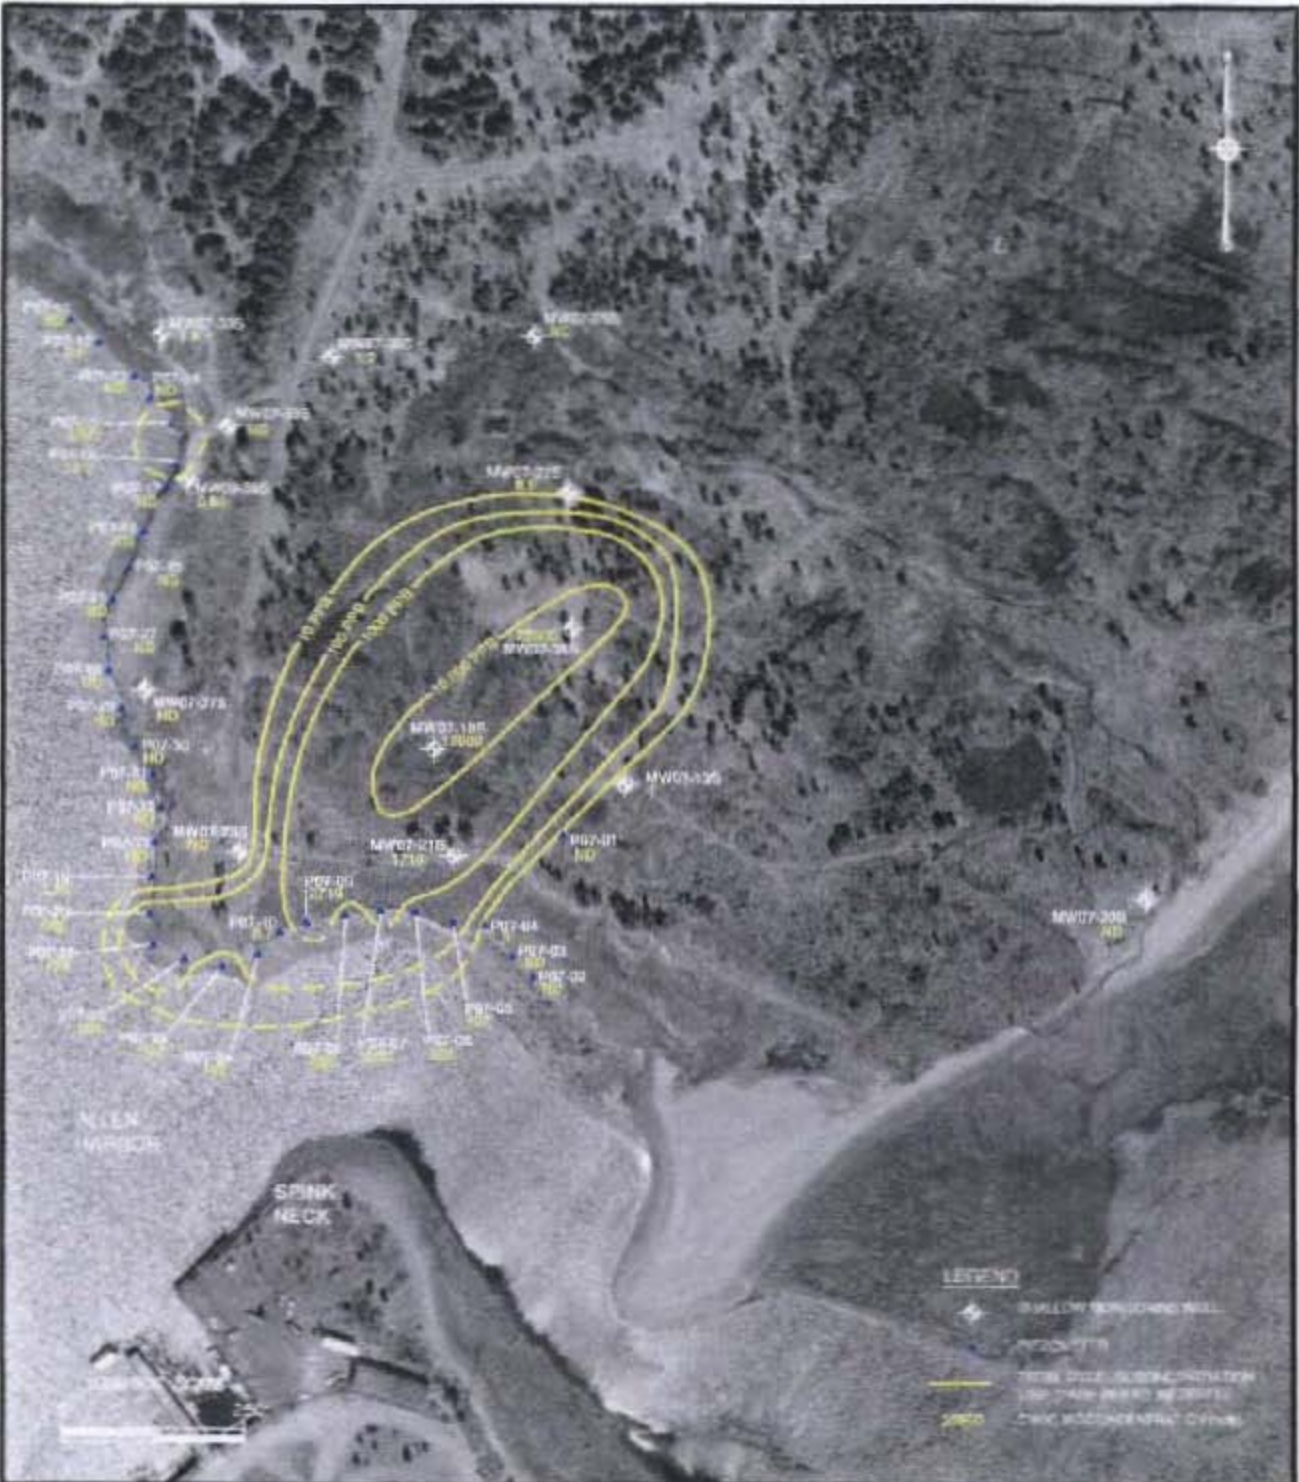
SCALE AS NOTED	
FILE \\006066\02\30\CVOC_SHAL_MCOB.DWG	
REV 0	DATE 02/29/08
FIGURE NUMBER 2-4

TOTAL CVOCs DETECTED IN SHALLOW GROUNDWATER MONITORING WELLS
MONITORING EVENT 08 - FEBRUARY/MARCH 2007
SITE 07, NCBC DAVISVILLE
NORTH KINGSTOWN, RHODE ISLAND

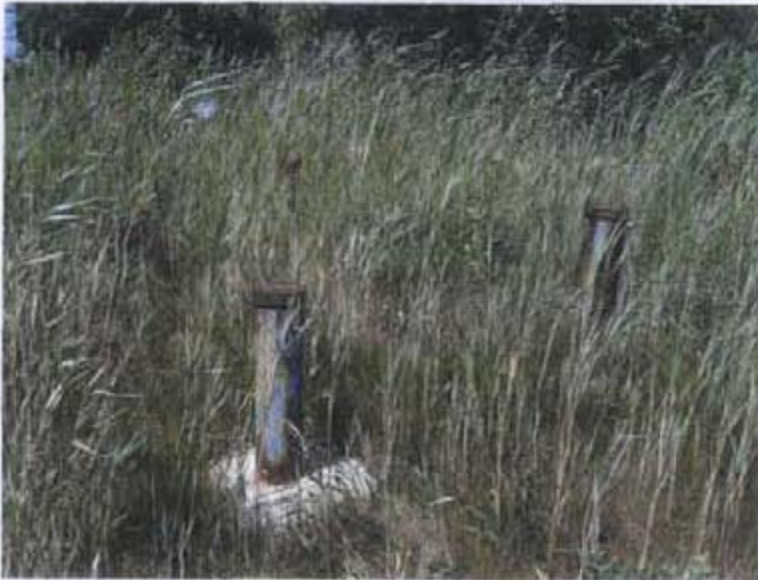
Photo No.: 1

Comments: View of monitoring well triplet MW07-21 on the southern boundary of the Calf Pasture Point (CPP) site.

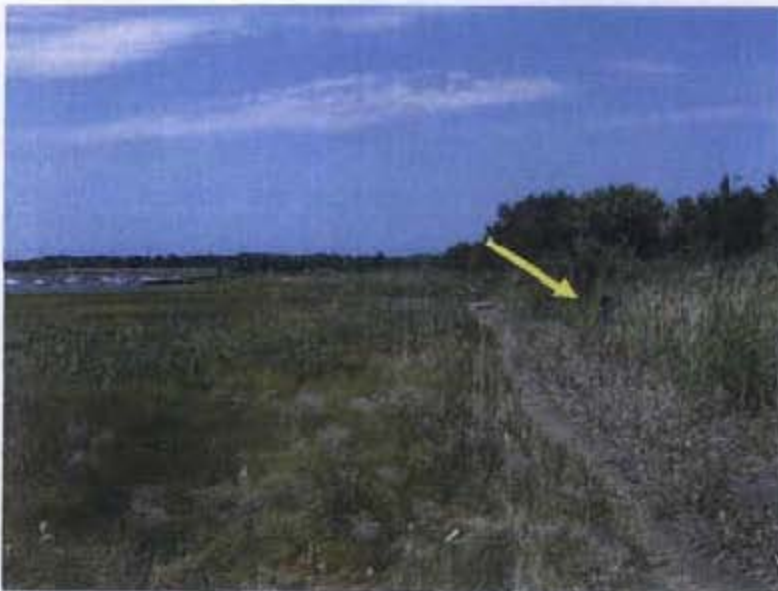
Photo No.: 2

Comments: View of the southern boundary of the CPP site looking west. Monitoring well triplet MW07-24 is visible on the right.

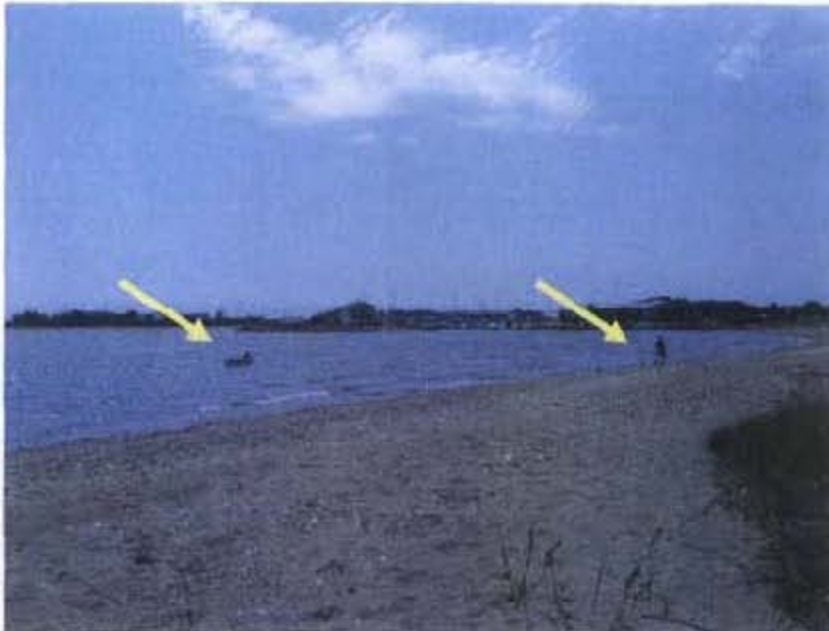
Photo No. 3

Comments: View of the eastern boundary of the CPP site adjacent to Narragansett Bay. Note two individuals wading in the bay for shellfish.

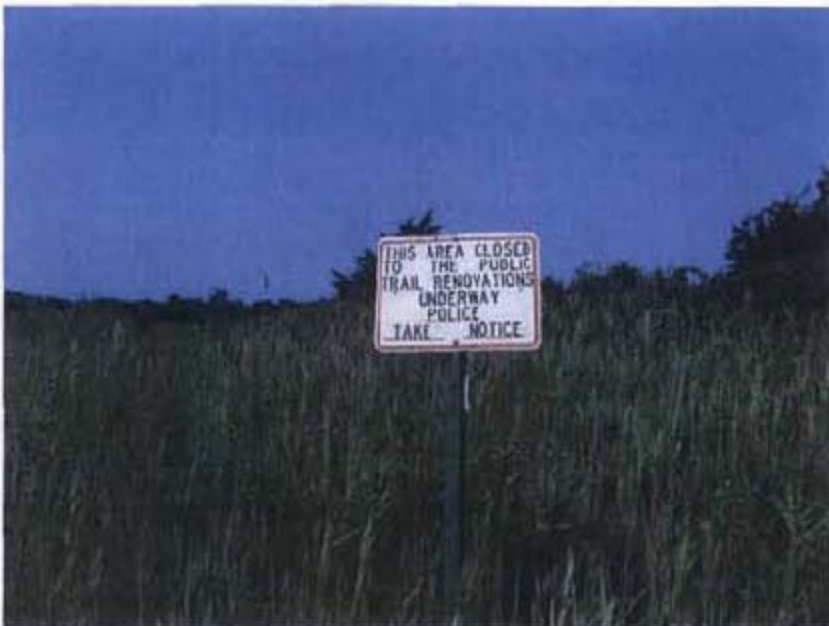
Photo No: 4

Comments: View of "Area Closed" sign posted along southern boundary of the CPP site.

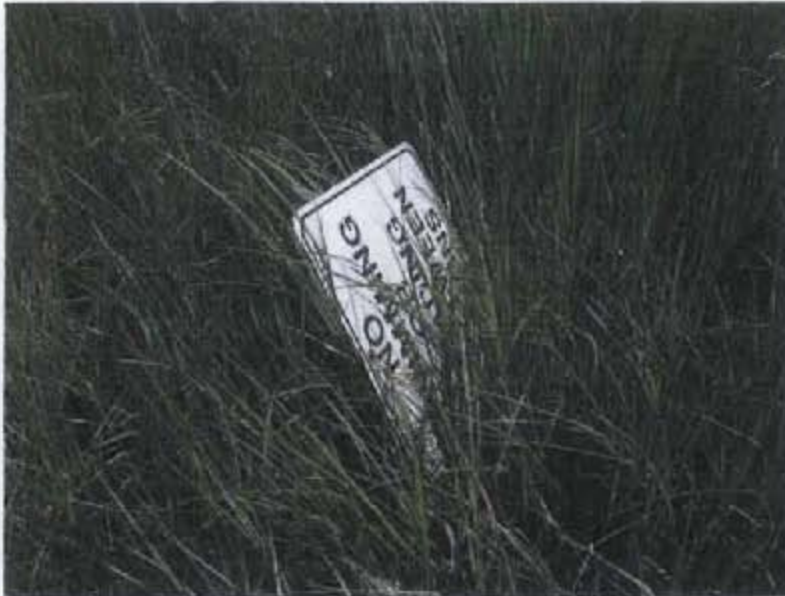
Photo No. 5

Comments: View of tipped over "No swimming or wading" sign along the southern boundary of the CPP site.

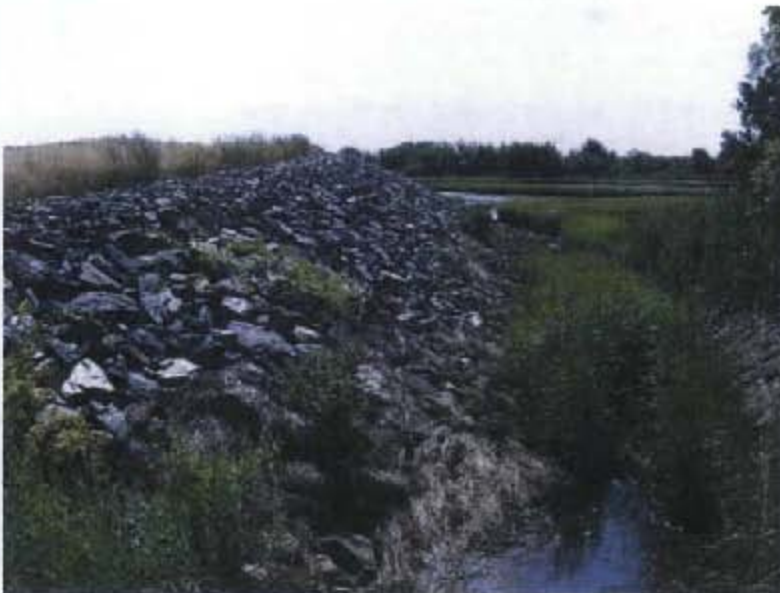
Photo No.: 6

Comments: View of revetment and southern drainage channel along the southern boundary of the Allen Harbor Landfill (AHL). Note vegetation growing on the revetment slope.

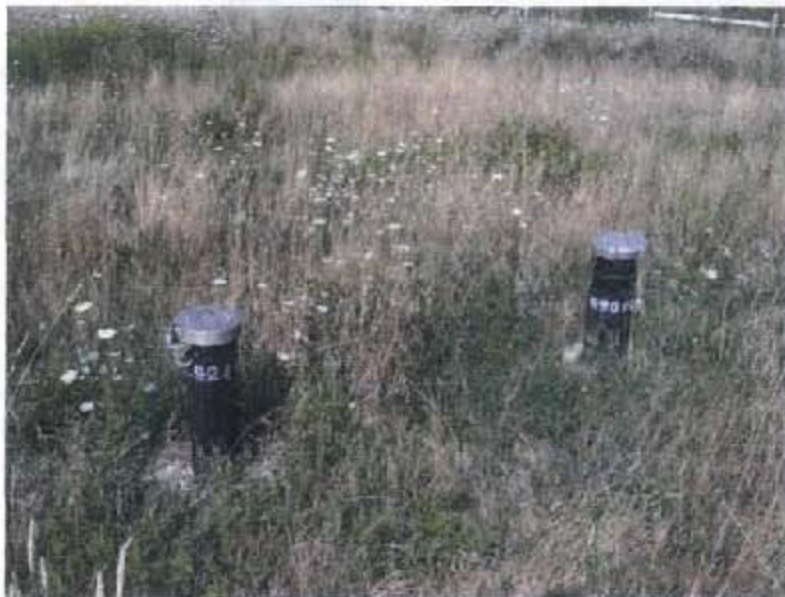
Photo No.: 7

Comments: View of monitoring well couplet MW09-24 located in southern portion of the AHL site. Note locked well casings.

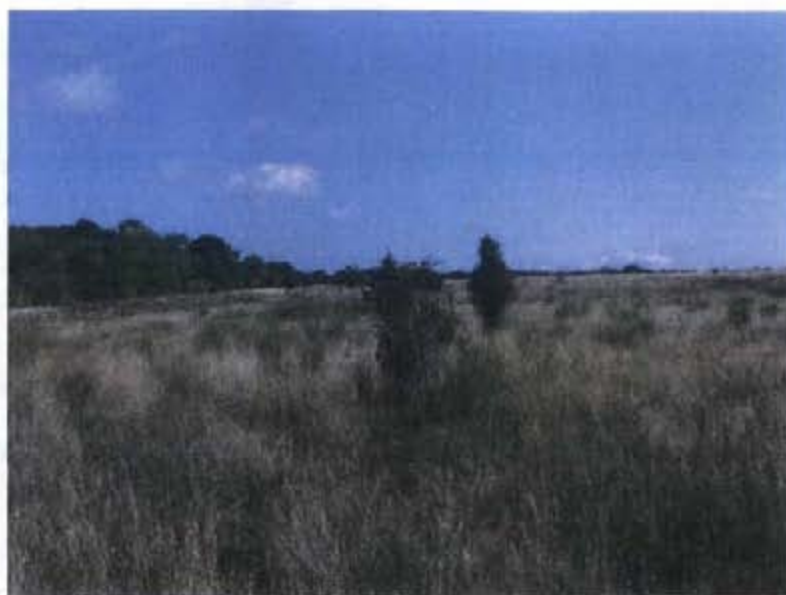
Photo No.: 8

Comments: View of landfill cap vegetation at the AHL site looking north.

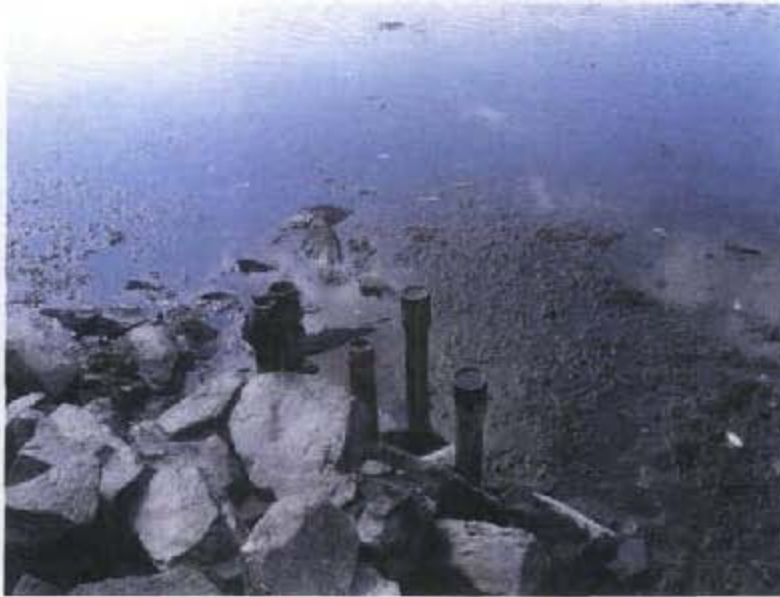
Photo No.: 9

Comments: View of piezometers PZ09-09 located along the southern boundary of the AHL site. Note piezometers are not capped.

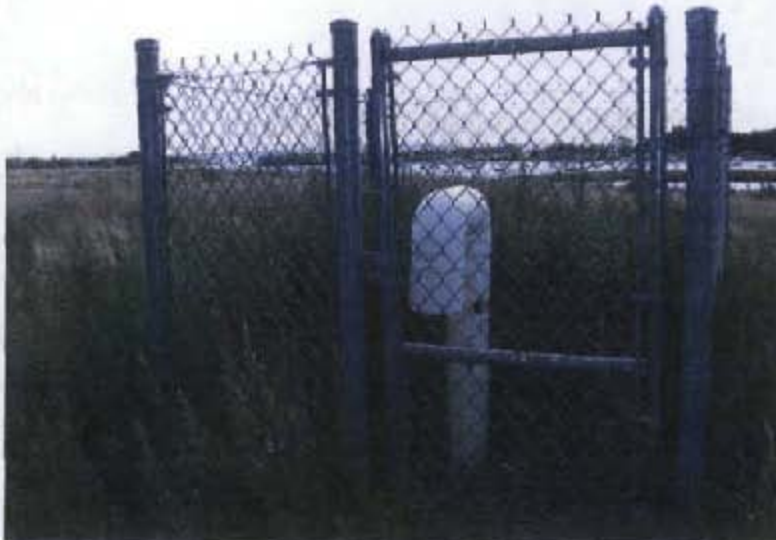
Photo No.: 10

Comments: View of landfill gas vent GV09-01 located on southern portion of the AHL site.

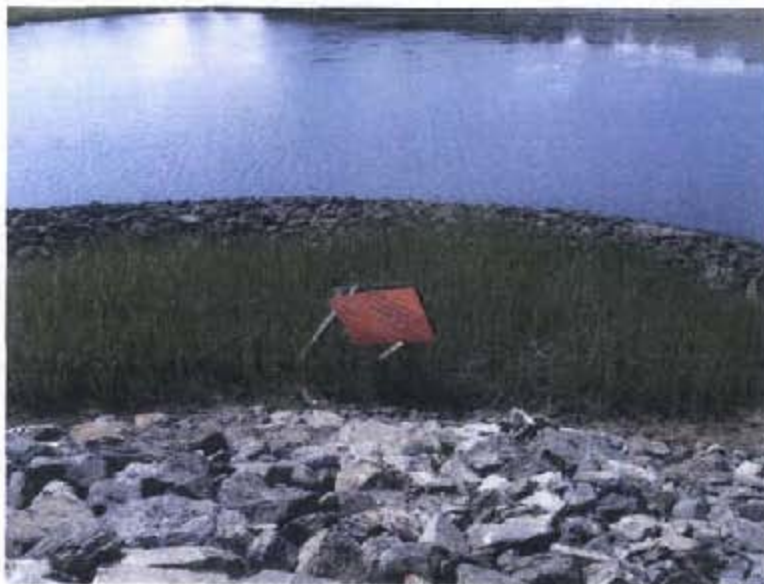
Photo No.: 11

Comments: View of tipped over "Polluted Area" sign and constructed shoreline wetland along eastern boundary of the AHL site.

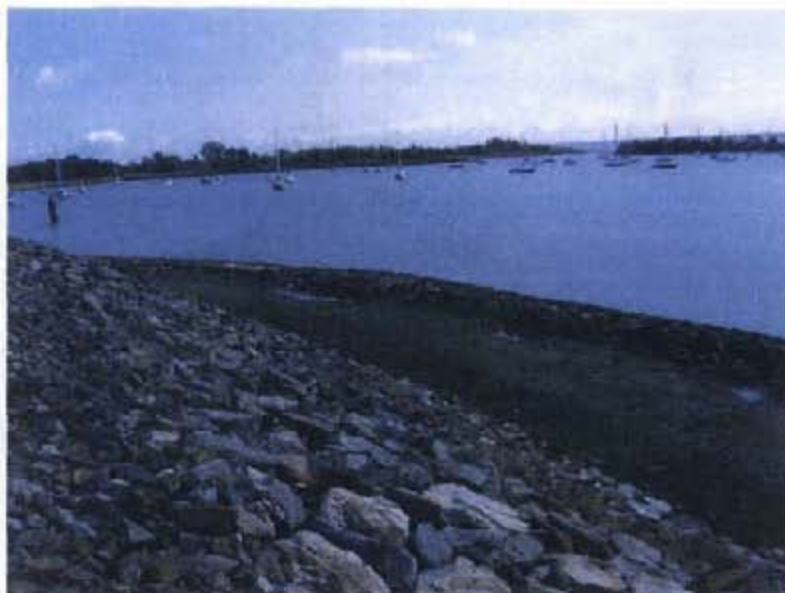
Photo No.: 12

Comments: View of area of constructed wetland that is bare of wetland vegetation along eastern boundary of AHL site.

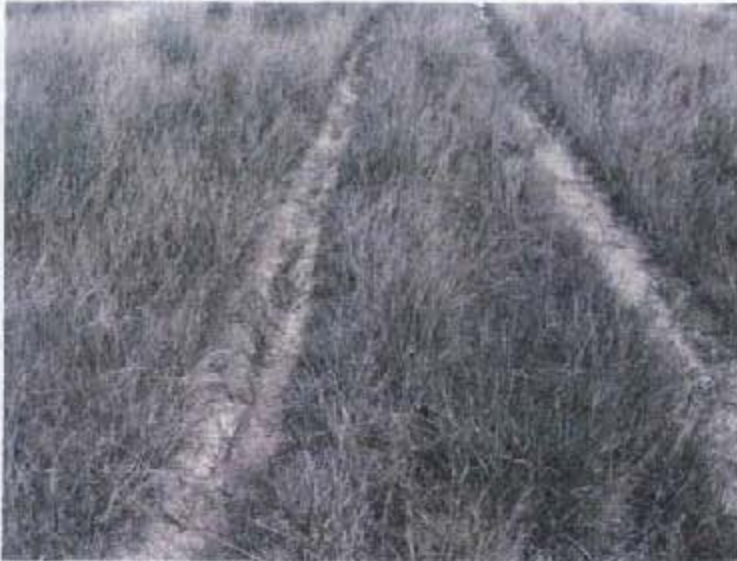
Photo No.: 13

Comments: View of
vehicle ruts on the
landfill cover of the
AHL site.

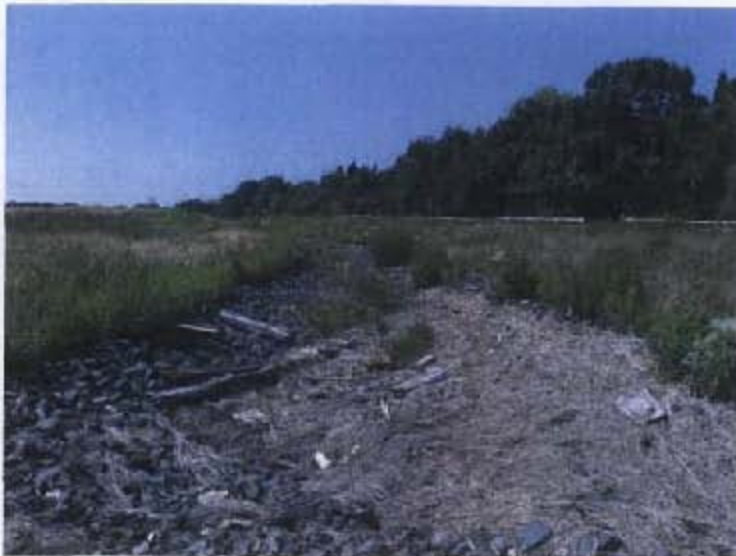
Photo No.: 14

Comments: View of
debris and vegetation
growing in the
northern drainage
swale of the AHL
site.

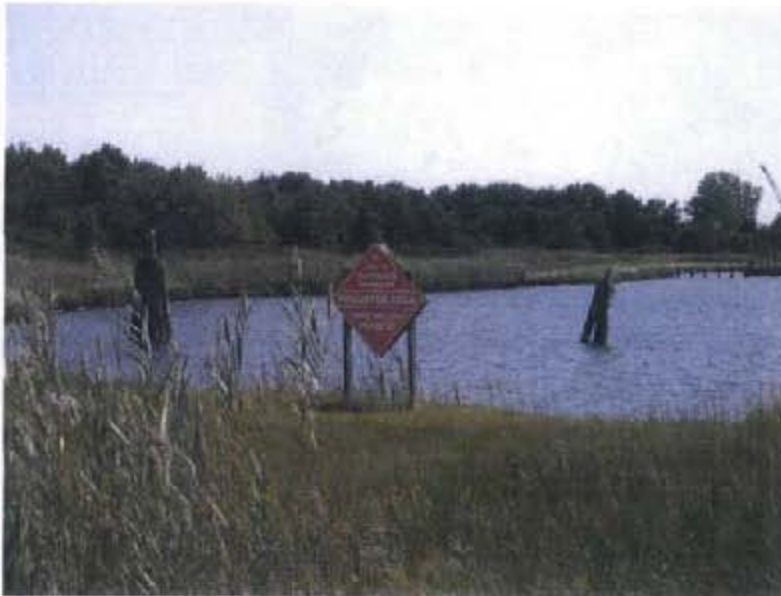
Photo No.: 15

Comments: View of
"Polluted Area" sign
along northeast
boundary of the AHL
site.

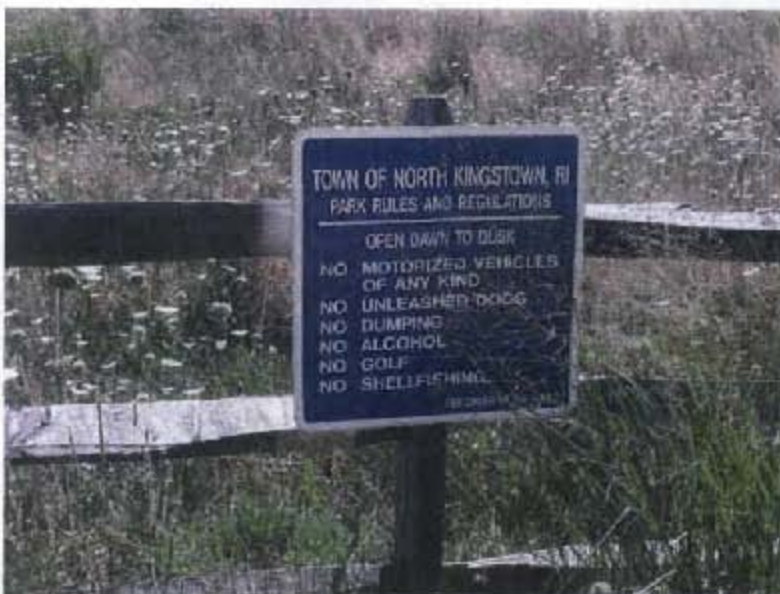
Photo No.: 16

Comments: View of
rules and regulations
sign along western
perimeter of the AHL
site.
